PUBLIC REALM CONDITION AUDITS

June 2024

Infrastructure and Public Works Committee

GOUGER STREET

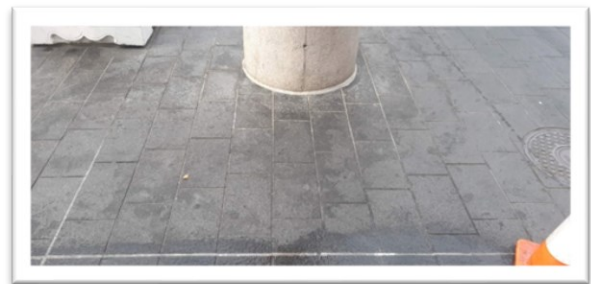
Observations noted that the footpaths were generally clean and tidy with some recent localised stains, chewing gum at the entrance of Moonta Street and several bins that required cleaning. The Cleansing Team completed the works on 17 April 2024.

Image 1 - Before - Stains and chewing gum - Moonta Street entrance

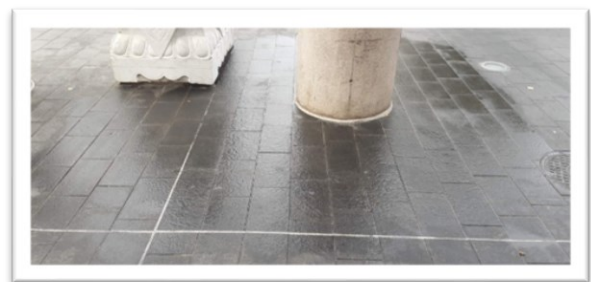
Image 2 - After cleansing team removed stains and chewing gum - Moonta Street entrance.

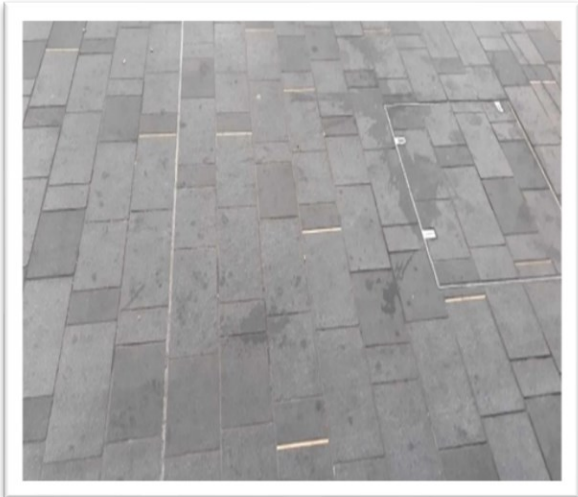
Image 3 - Chewing gum and stains within Moonta Street

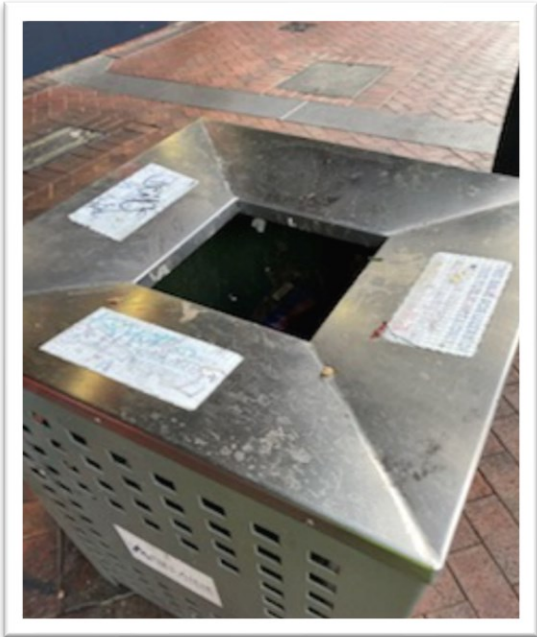
Image 5 - Bin enclosure - 64 Gouger Street - before

Several bin enclosures located in front of 64 and 100 Gouger Street required attention and have since been cleaned.

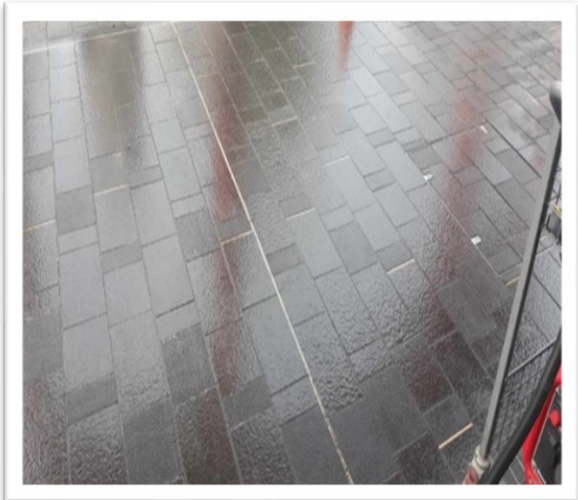
Image 4 - After photo showing chewing gum and stains removed.

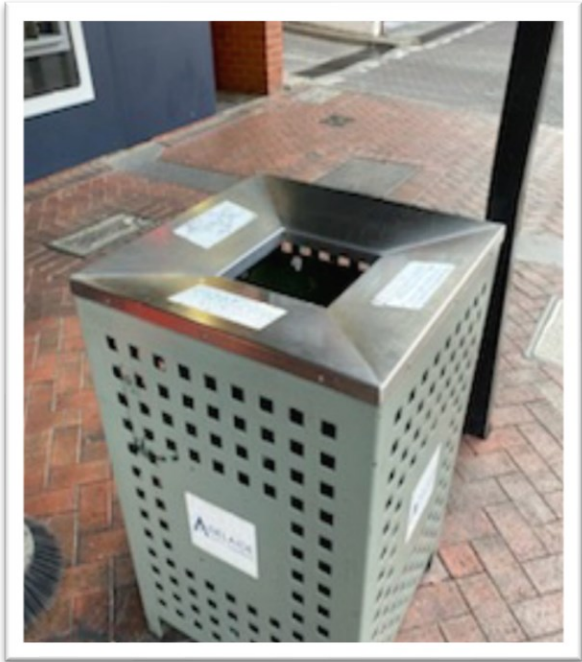
Image 6 - Bin enclosure - 64 Gouger Street - after

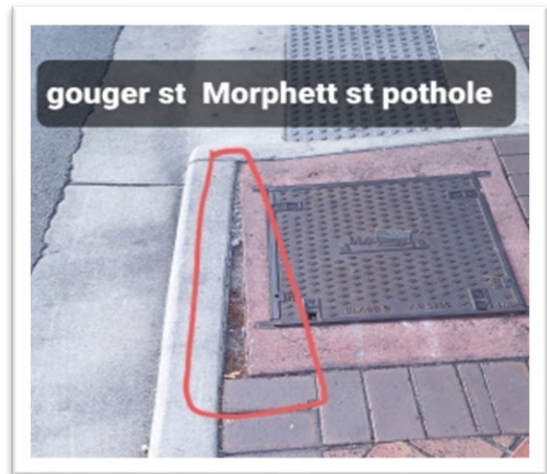
Many of the defects noted related to pit and pit surrounds. It was discussed on-site that pits are generally under the care and control of the Service Authority that owns the underground assets. Staff have reported these issues directly to the relevant Service Authority to action.

Image 1 - Gap between pit surround and kerb at the intersection of Gouger Street and Morphett Street

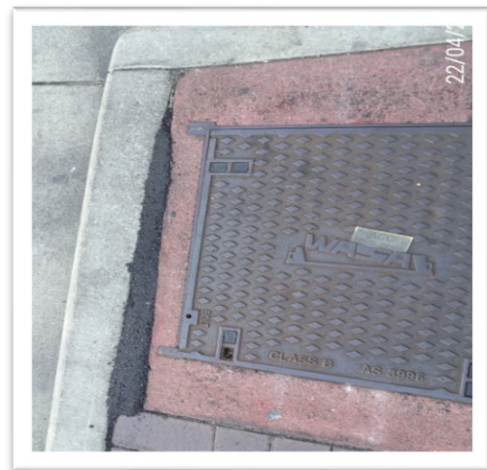
Image 2 - After photo showing cold mix asphalt in place.

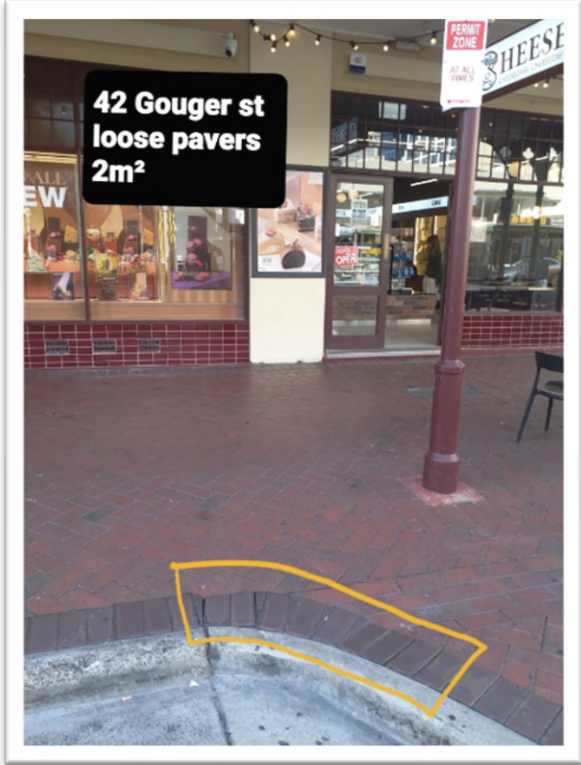
Other footpath defects noted were trip hazards created when pavers lift and move. City Operations staff briefly discussed the maintenance approach to quantifying these defects:

Image 3 - Loose pavers noted along back of kerb at 42 Gouger Street

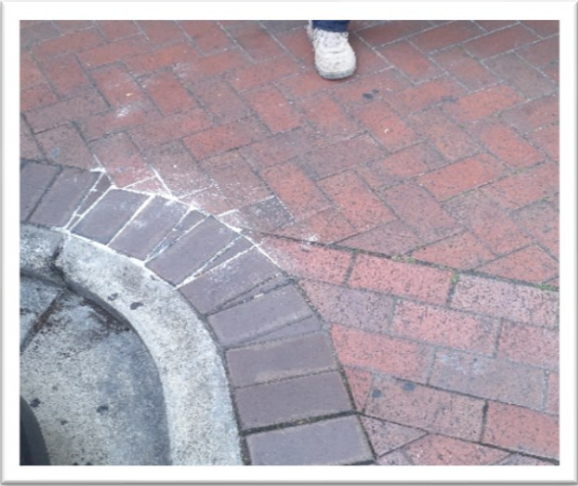
Image 4 - Loose pavers repaired and sweeping sand applied.

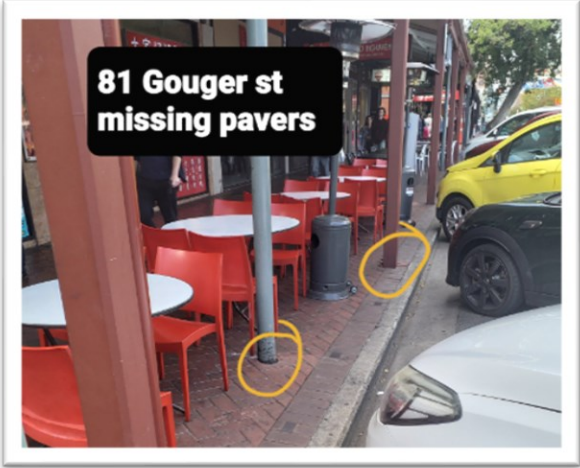
Image 5 - Missing pavers and gaps noted at base of veranda poles at 81 Gouger Street

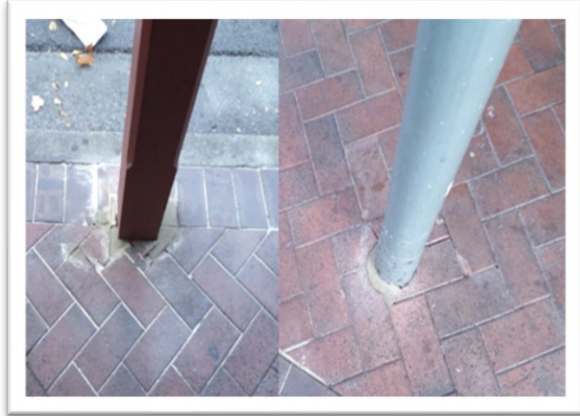
Image 6 - Pavelock and pavers placed at base of veranda poles.

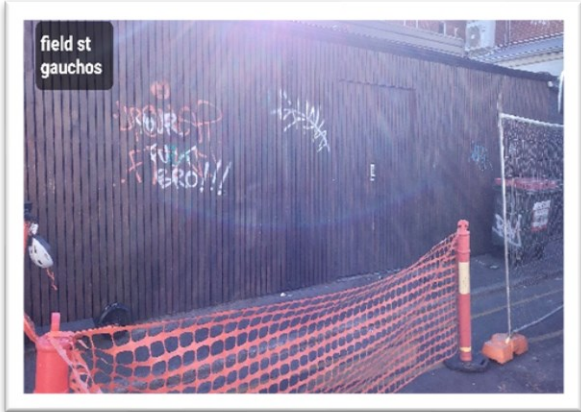
Image 7 - Graffiti noted on Field Street - Gauchos Restaurant – before.

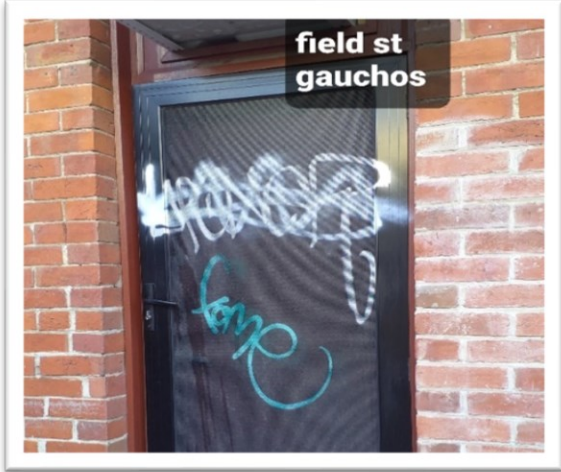
Image 9 - Graffiti on the side door of Gauchos - before

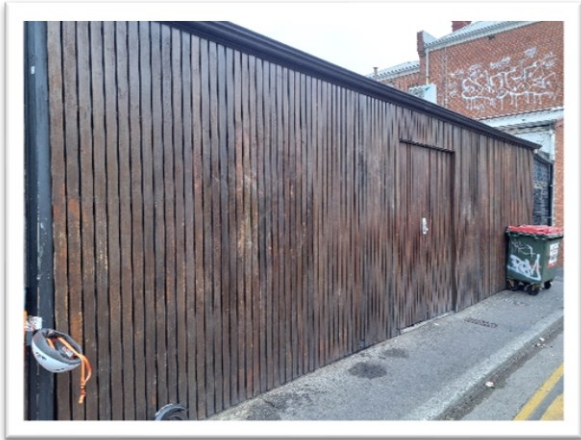
Image 8 - Graffiti noted on Field Street - Gauchos Restaurant – after.

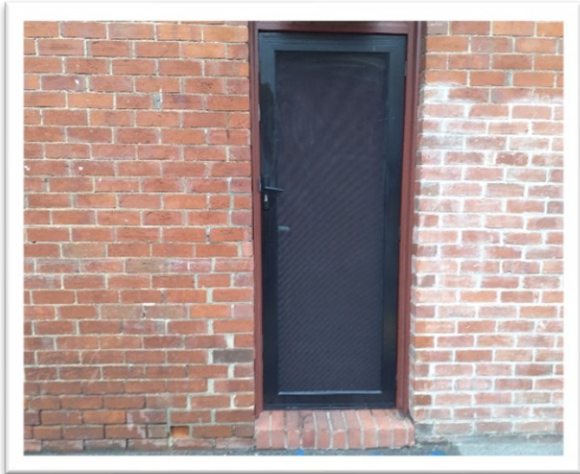
Image 10 - Graffiti removed from side door – after

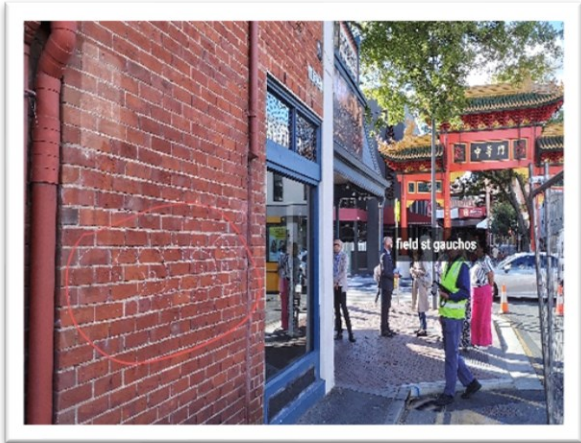
Image 11 - Chalk like graffiti identified on the side of Gauchos - before.

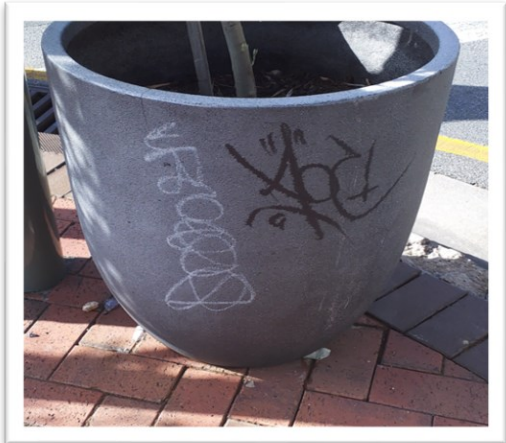
Image 13 – Graffiti observed on a pot plant – corner of Gouger Street and Mill Street

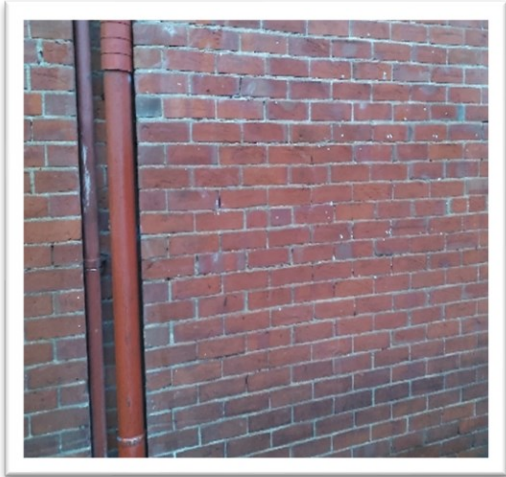
Image 12 - Chalk like graffiti removed.

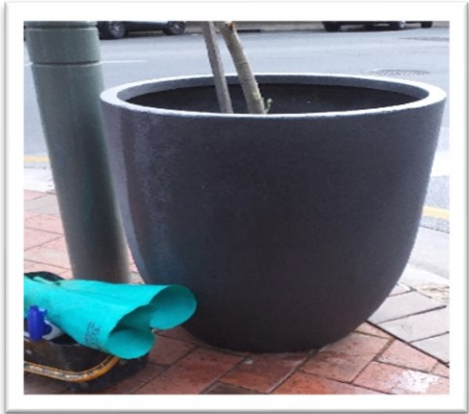
Image 14 – Graffiti removed.

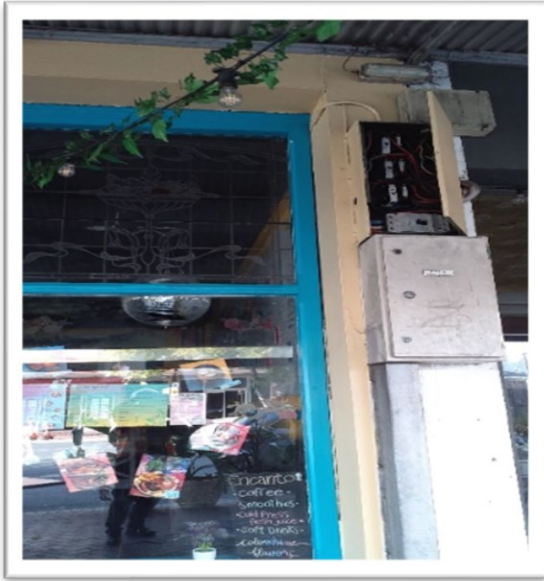
The condition audit identified several issues with private infrastructure. Staff from Regulatory Services have followed up with business owners to take action. One issue was at 183 Gouger Street, where a fuse box cover was missing.

Image 15 - Missing fuse box cover

The business owner was notified and requested to action.

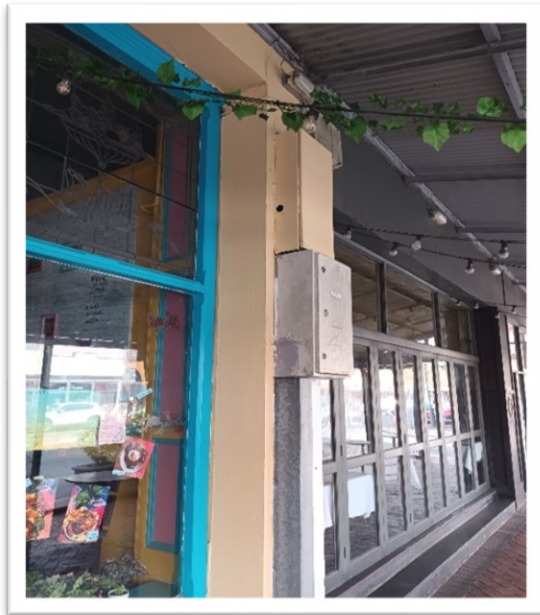
Image 21 - Fuse box cover fixed

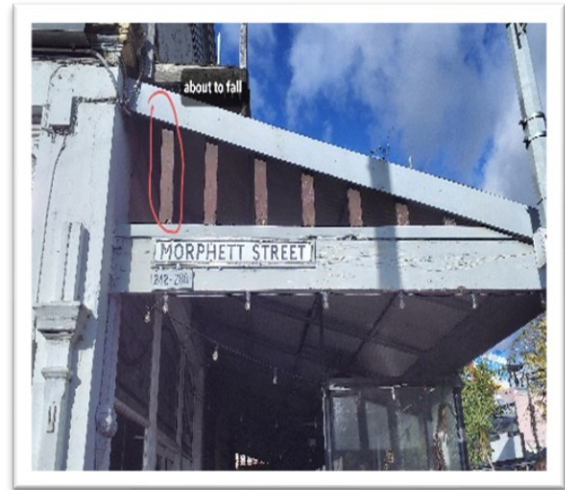
Structural concerns on the attached veranda and a planter box requiring maintenance were identified at 280 Gouger Street

Image 22 - Loose railing.

Requests have been made for the repair, removing the loose rail to make safe, requesting a structural engineering assessment on the rest of the veranda, and requesting the business owner to fix the planter boxes.

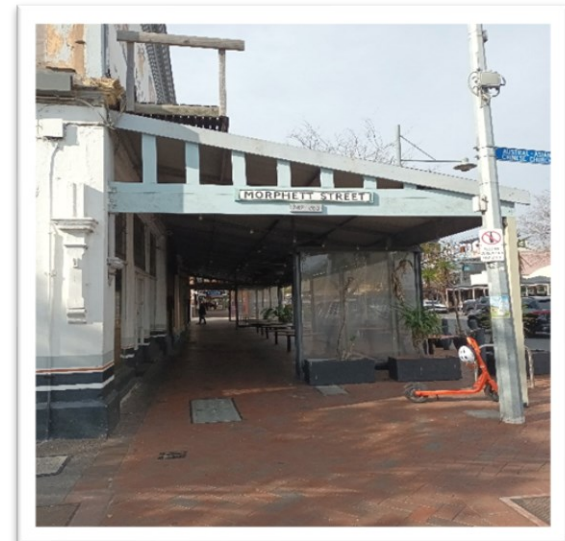
Image 23 - Loose railing fixed.

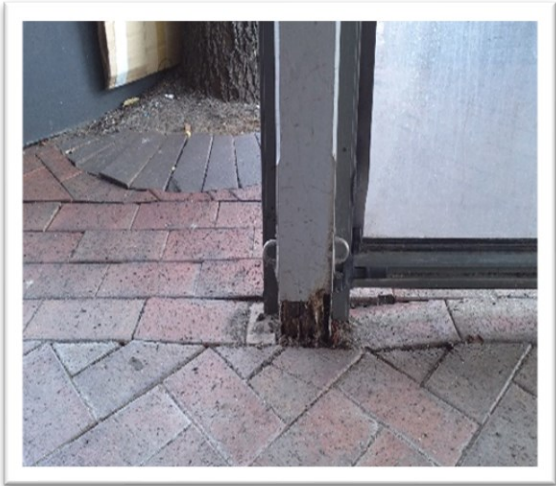
Image 24 - Damaged footing

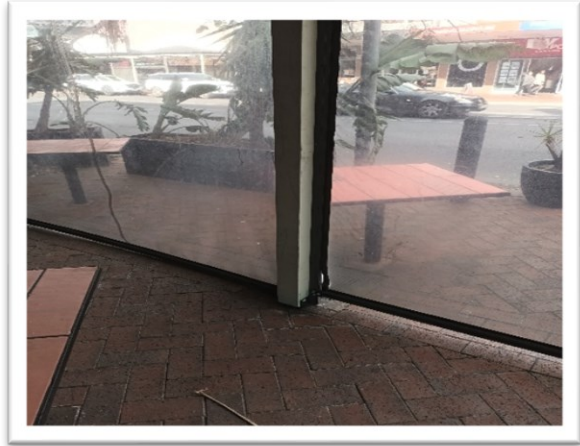
Image 25 - Damaged footing fixed

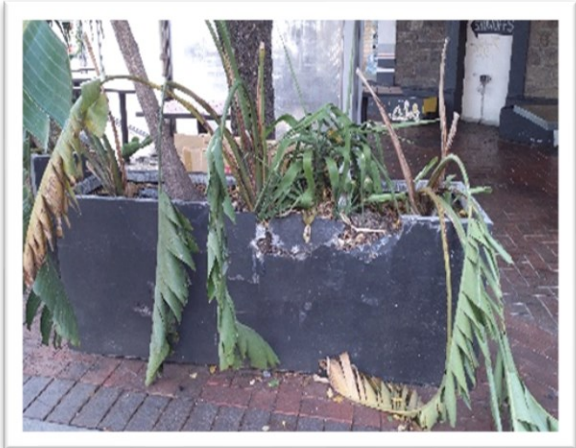
Image 26 - Planter box requiring maintenance.

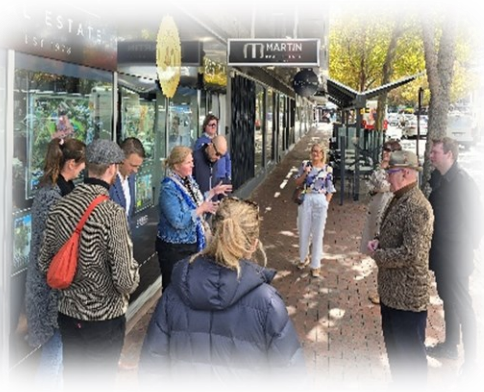
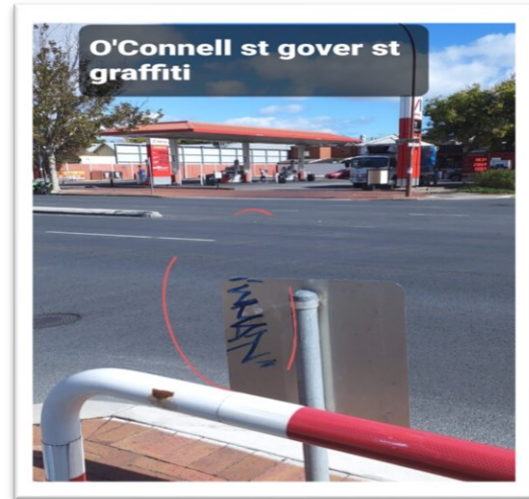
Image 27 - Graffiti identified during Condition Audit

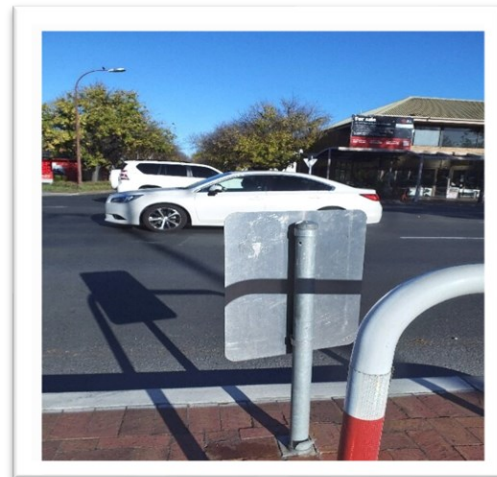
Image 28 - Graffiti removed by Cleansing team

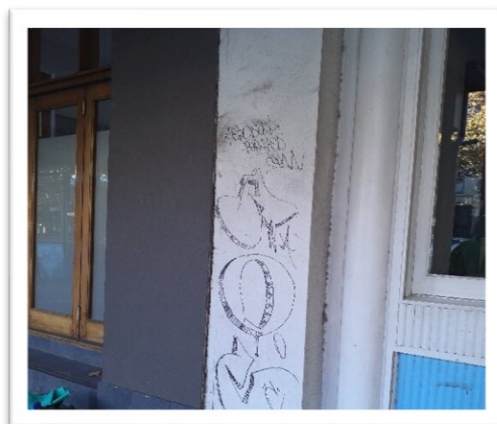
Image 29 - One of the six additional instances of graffiti identified.

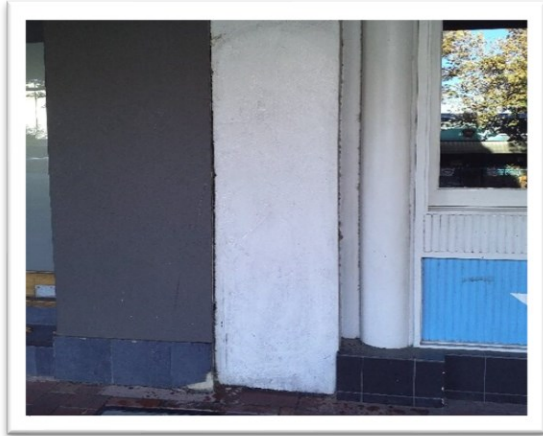
Image 30 - Graffiti removed

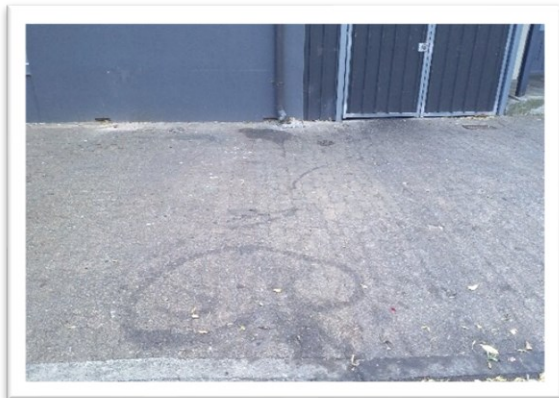
Several areas required a deep clean to remove the build-up of grime and stains. The Cleansing team completed this work over several days, with work completed Friday 3 May 2024.

Image 31 - Oil-stained footpath requiring a deep clean - 22 O'Connell Street - side street

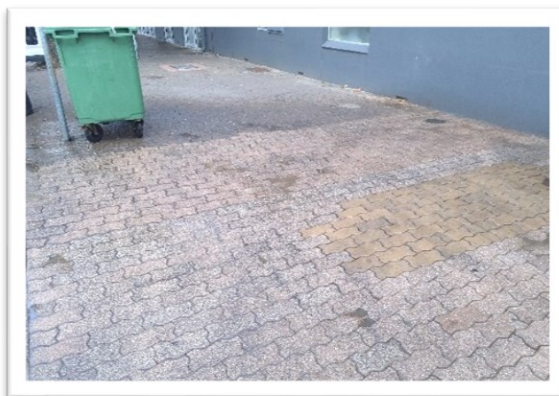
Image 32 - Progress shot of deep cleaning showing grime removal in process - 22 O'Connell Street

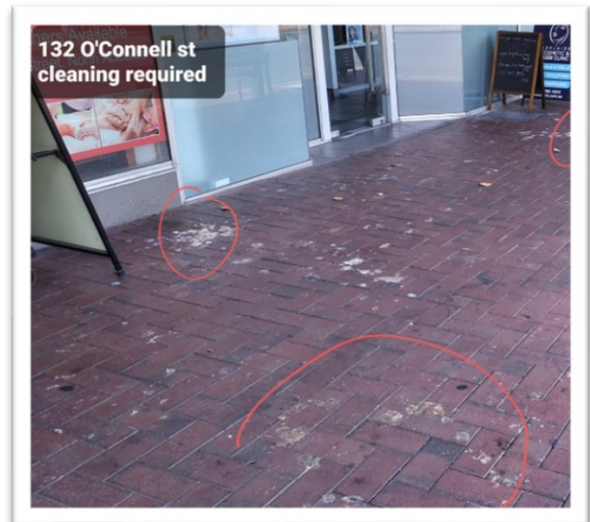
There were isolated areas of concentrated bird droppings requiring cleaning.

As discussed during the audit, the Cleansing Team work hard to provide clean and visually appealing footpaths, with bird faeces an ongoing issue. These instances appear in very short timeframes with birds roosting in groups. Many buildings install bird nesting deterrents as a control mechanism.

Image 33 - Concentrations of bird droppings under roosting areas

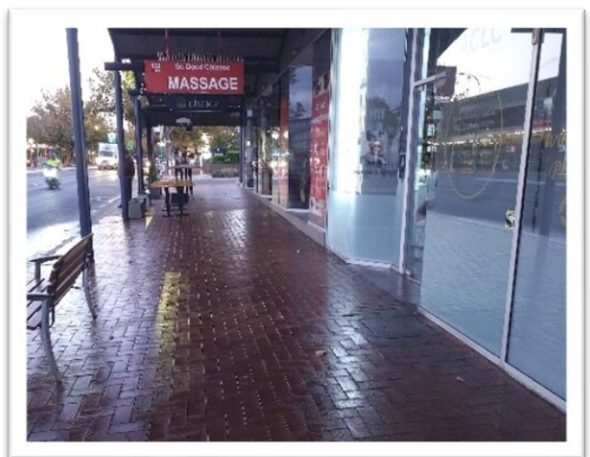
Image 34 - Reverse angle of 132 O'Connell Street - after deep clean

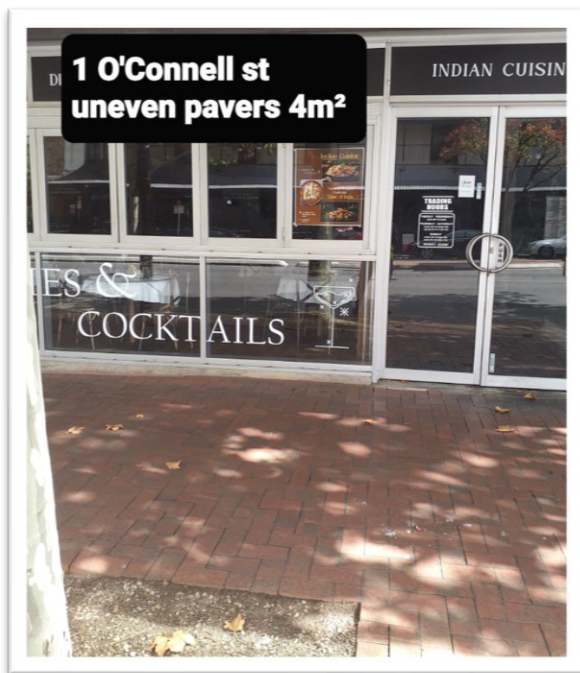
Several areas of raised pavers were observed along O'Connell Street on the western side.

These generally coincided with the interface between the footpath edge and the box around street trees.

Image 35 - Area of paving requiring maintenance

The remaining works total approximately 122m² and have been programmed to be completed by the end of the financial year.

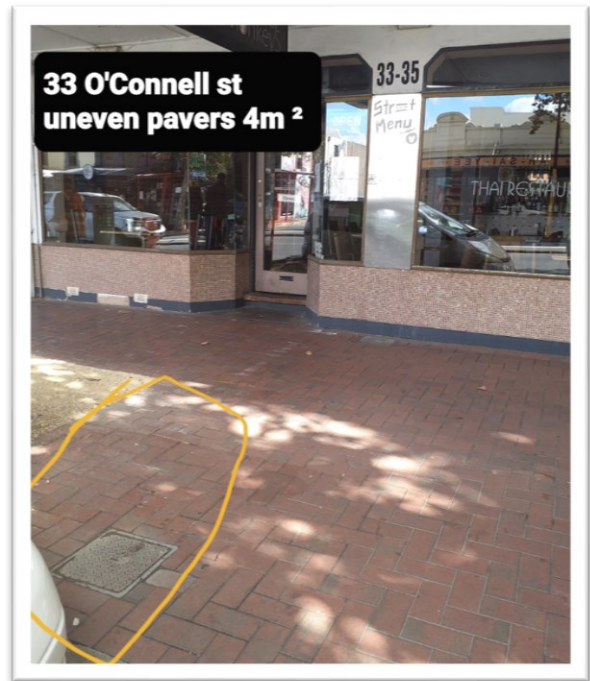
Image 36 - Area of paving requiring maintenance

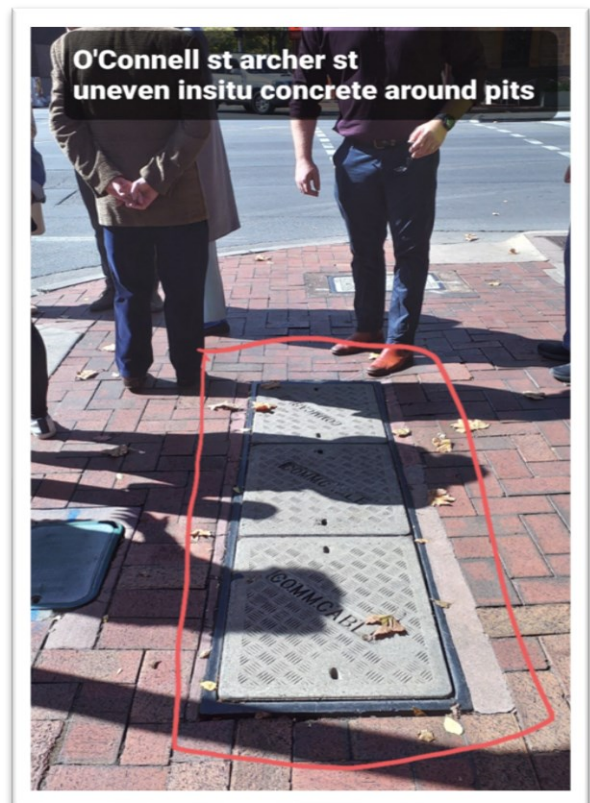
Quality of reinstatements undertaken by Service Authorities were also noted along both sides of O'Connell Street.

Image 37 - Area of paving requiring maintenance

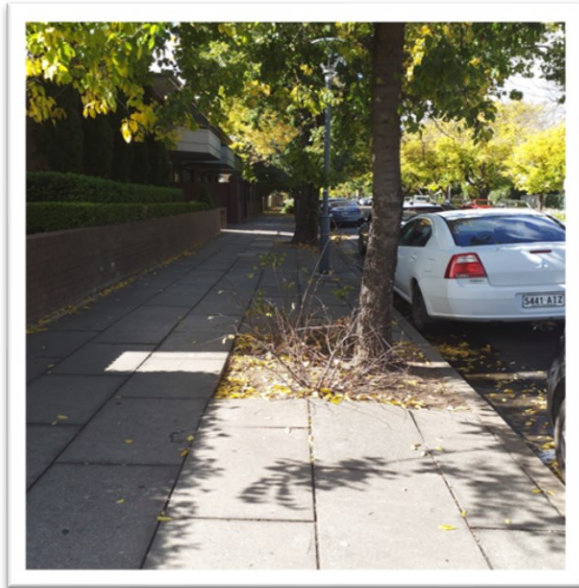
Street trees were generally in good condition, with localised suckering (epicormic growth) at the base of 5 trees and two instances of tree branches requiring removal.

Image 38 - Suckering present in tree at 107 Gover Street

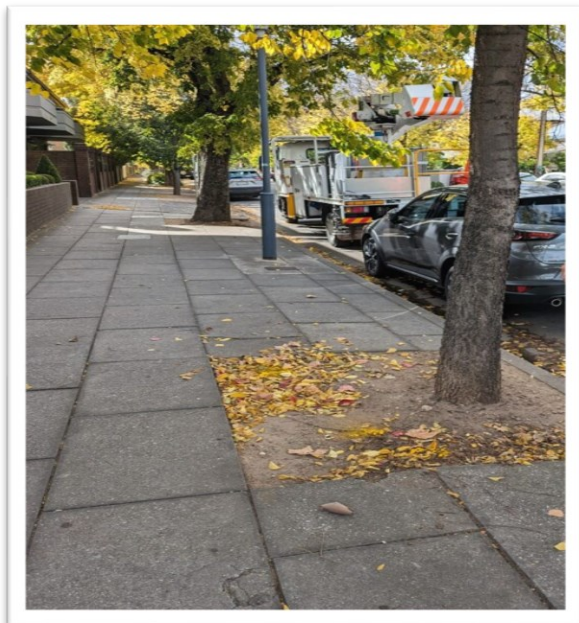
Image 39 - Suckering removed at 107 Gover Street

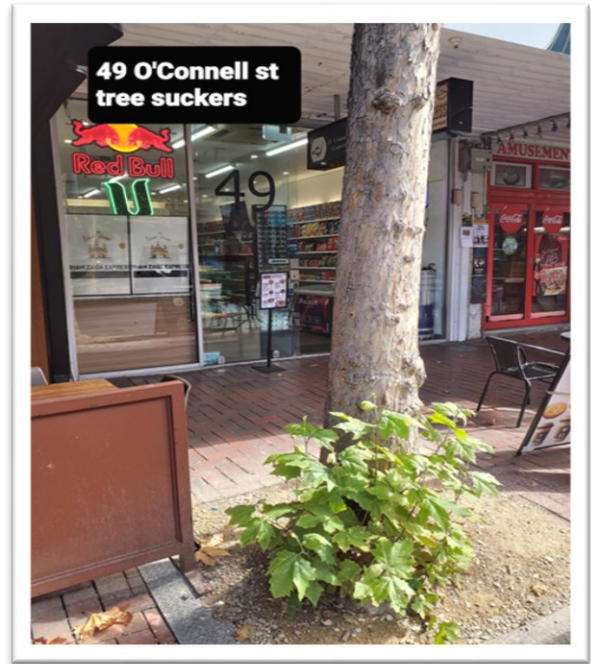
Image 40 - Suckering present in front of 49 O'Connell Street

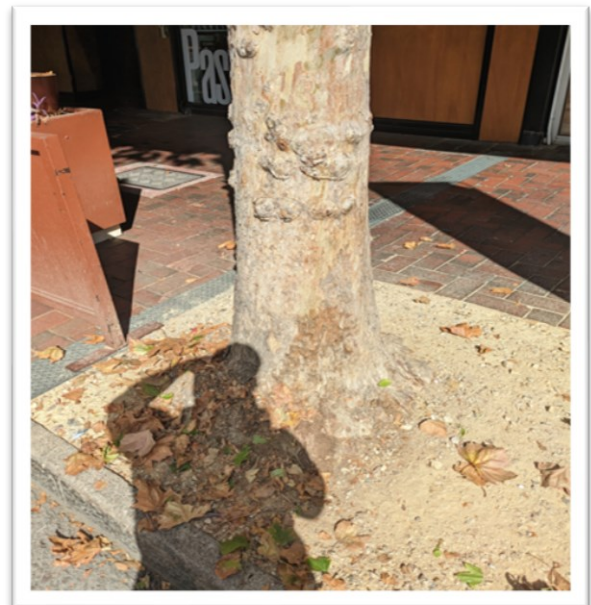
Image 41 - Suckering removed from tree in front of 49 O'Connell Street

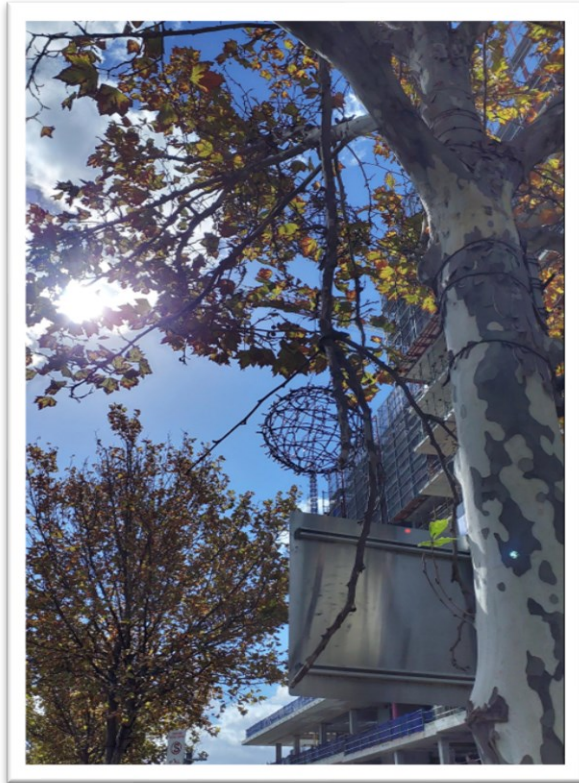
Image 42 - Branch requiring removal 88 O'Connell Street

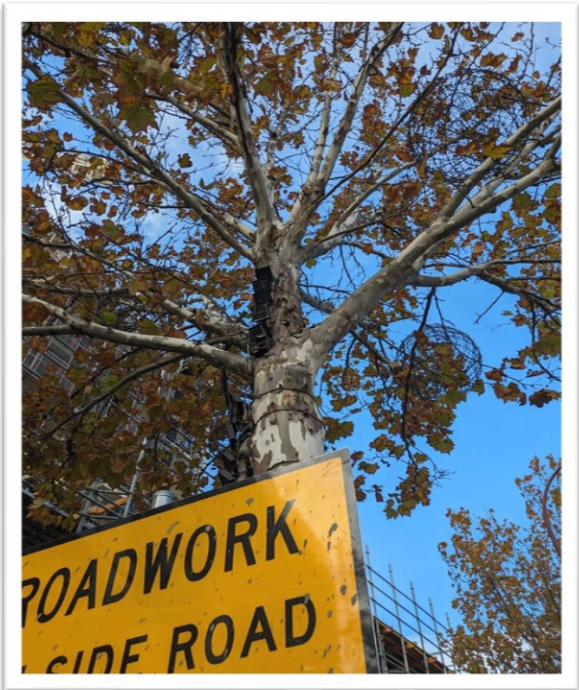
Image 43 - Branch removed in front of 88 O'Connell Street

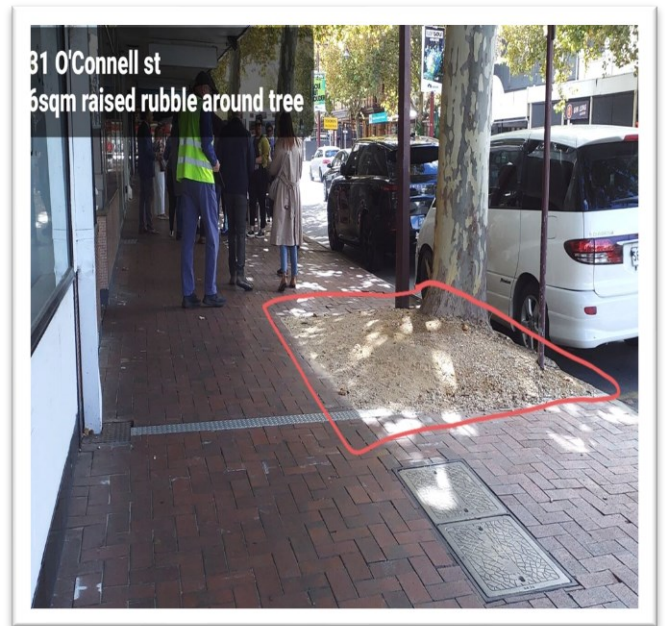
Primarily along the western side of O'Connell Street, the existing mature street trees presented with raised rubble beds because of capping tree roots.

Image 44 - raised rubble.

City Operations staff have capped these to provide a safe footpath network without presenting a risk to the health of the tree. These legacy plantings impact the whole city and solutions to these are limited from a maintenance perspective, where removal of a tree is not warranted.

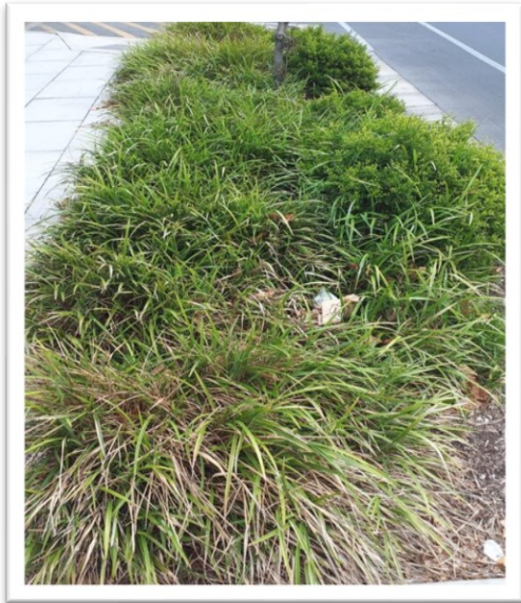
Image 45 - Garden bed at intersection of O'Connell Street and Tynte Street requiring maintenance

Garden beds presented in good condition. Ten garden beds have been programmed for localised re-planting and general tidy work.

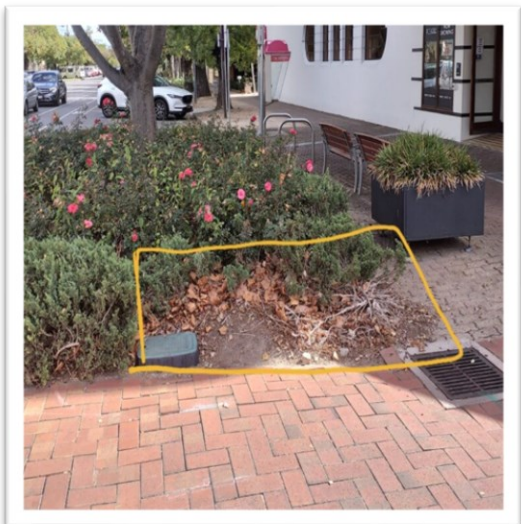
Image 46 - Garden bed at the intersection of O'Connell Street and Childers Street requiring maintenance.

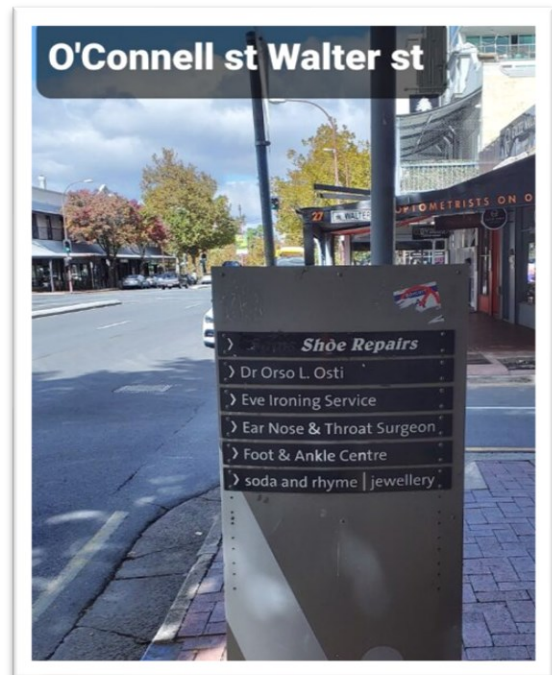
It was noted that directional signage was out of date and had a lacklustre appearance.

Image 47 - Outdated Way Finding Signage

Directional signage is currently being phased out in favour of our new wayfinding strategy across the city, that has a focus on providing pedestrians and cyclists with on-street information, to help connect visitors and locals with public transport, detailed areas, historical walks and local facilities.

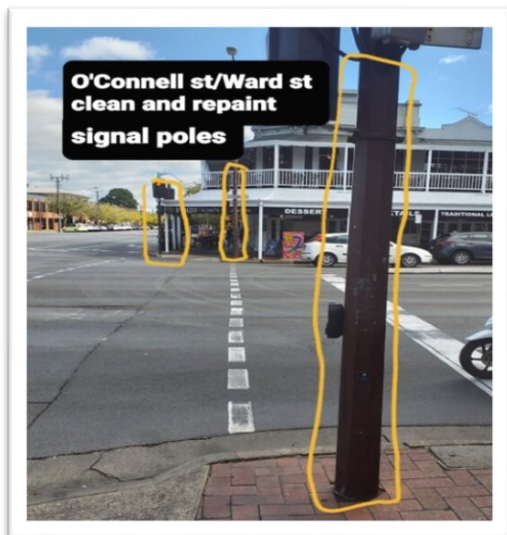
Image 49 – Poles identified through collaborative action.

While crews have been undertaking the works identified through this Condition Audit, other works have been identified and programmed in. This includes collaborative actions, such as the Cleansing Team removing stickers from street furniture and poles and notifying the Urban Elements Team that follow-up works, including painting, is warranted. This will be programmed in for future works as budget and resources allow.

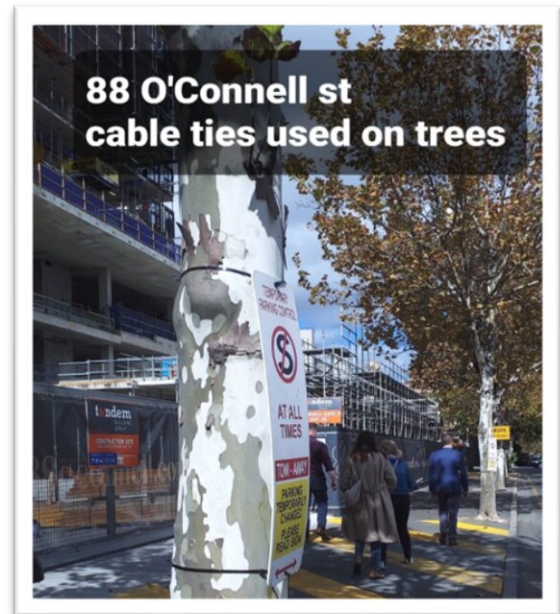
City Operations staff noted that Temporary Parking Control signage was cable tied to trees. These signs have been moved to hard infrastructure to reduce impacts on tree health.

Image 50 - Signage installed on tree.

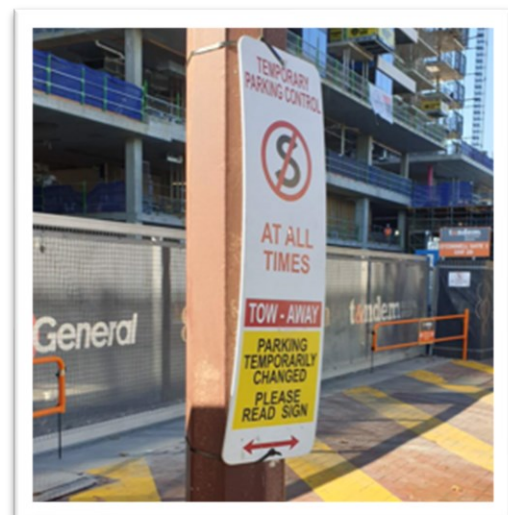
Image 51 - Signage moved to hard infrastructure.

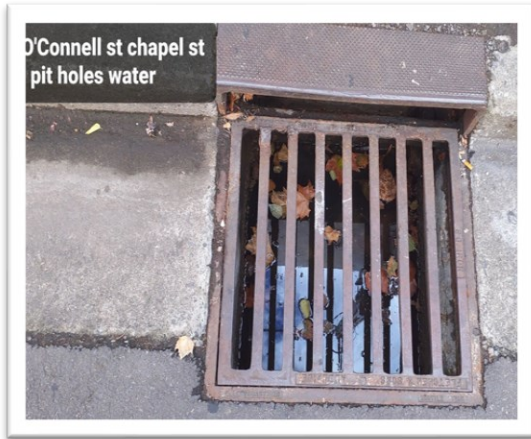
Observations of the grated inlets noted that some held debris and water. These are being attended to as a part of the broader Flood Resilience Project.

Image 52 - Catch pit holding water.

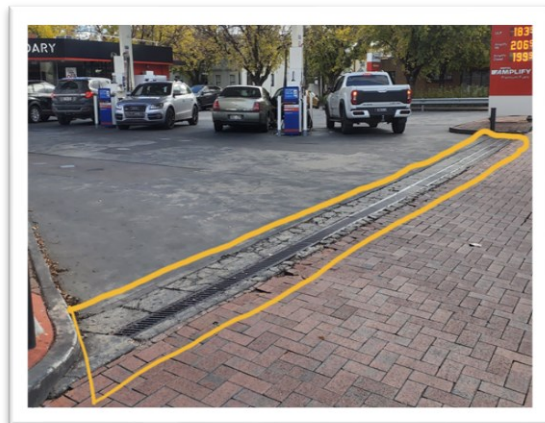
Pavers are raised through the driveway entry to the service station. Council will programme in the works in the public realm whilst contact is being made with the business owner to report the damage to private infrastructure.

Image 53 - Damaged infrastructure 131 O'Connell Street

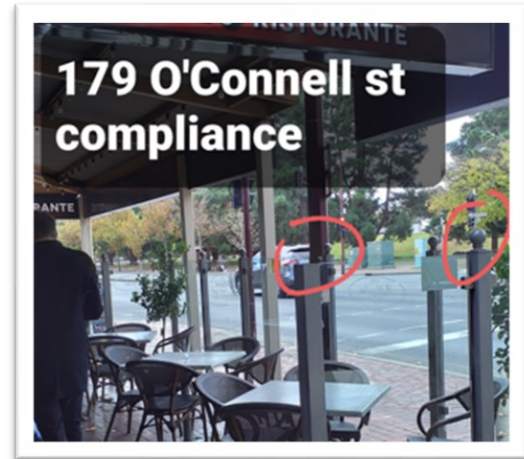
There were several missing caps along the outdoor dining areas. Members of the Regulatory Team have contacted the business owners requesting that the capping be replaced.

Image 54 - Missing capping 179 O'Connell Street

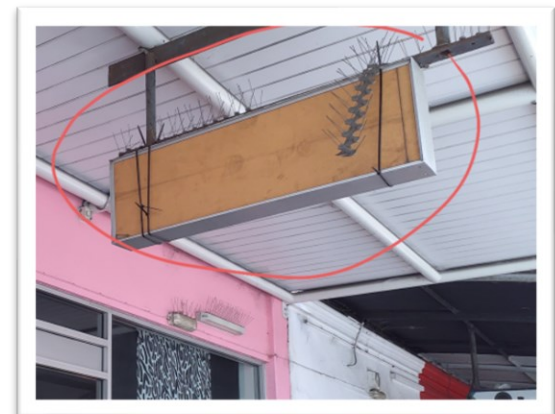
The attendees noted that an anti-bird device was not installed correctly at 112 O'Connell Street. The business owner has been contacted to rectify.

Image 55 - Anti-bird device not installed correctly.

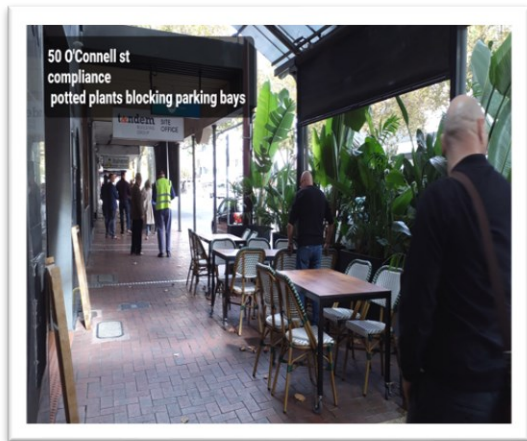
The planter boxes located at 50 O'Connell Street were observed to be located immediately behind the kerb line making it difficult for vehicle passengers to exit the vehicle. The business owner has been contacted and requested to move the planter boxes 900mm from the kerb.

Image 56 - Planter boxes at 50 O'Connell Street close to kerb

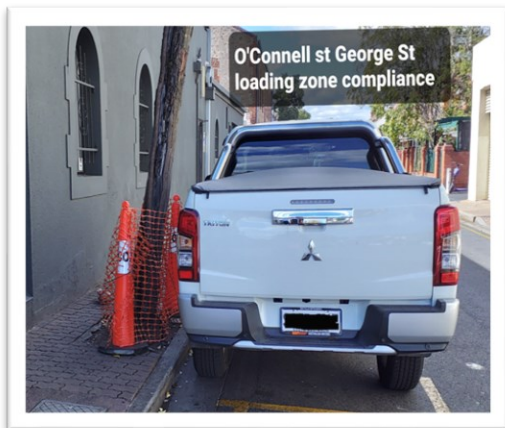
A loading zone on George Street was brought to attention, citing that vehicles were not adhering to the parking requirements, and that loading zones were sparse in the area making it difficult for shops to receive goods. The Parking and Information Officers will monitor this area more closely in the short-term to deter vehicles from parking illegally.

Image 57 - Loading zone - George Street

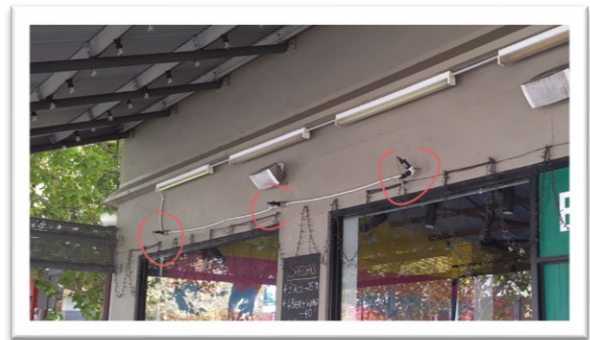
Finally, the group noted that there was lighting installed in two outdoor dining areas. A question was asked around the appropriateness of the installation.

Image 58 - Light installation

Council staff have contacted Office of the Technical Regulator and SafeWork SA to review these installations to ensure that they meet all requirements.
