# PUBLIC REALM CONDITION AUDITS

June 2024

Infrastructure and Public Works Committee

#### **GOUGER STREET**

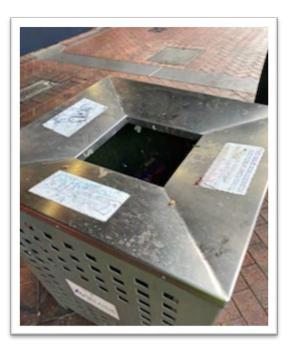
Several bin enclosures located in front of 64 and 100 Gouger Street required attention and have since been cleaned.

Image 5 - Bin enclosure - 64 Gouger Street - before

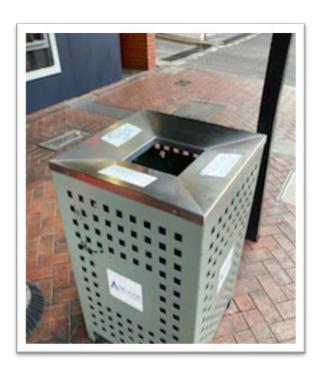
Image 6 - Bin enclosure - 64 Gouger Street - after

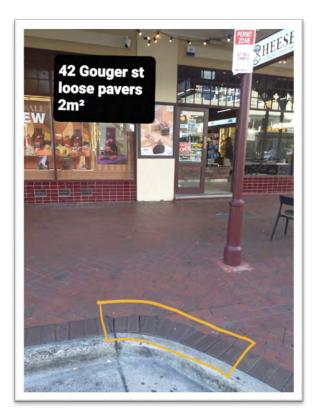
Other footpath defects noted were trip hazards created when pavers lift and move. City Operations staff briefly discussed the maintenance approach to quantifying these defects:

When hazards are identified, the lip is quantified in three categories. Lips between 0mm and 9mm are monitored (unless there are other critical factors). Lips between 10mm and 19mm are programmed in and triaged against other programmed works. Any lip 20mm or more is attended to by the Rapid Response Team to repair if possible or make safe.

Image 3 - Loose pavers noted along back of kerb at 42 Gouger Street

Image 4 - Loose pavers repaired and sweeping sand applied.

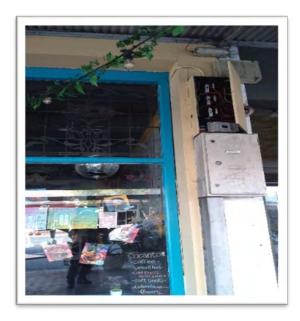
The condition audit identified several issues with private infrastructure. Staff from Regulatory Services have followed up with business owners to take action. One issue was at 183 Gouger Street, where a fuse box cover was missing.

Image 15 - Missing fuse box cover

The business owner was notified and requested to action.

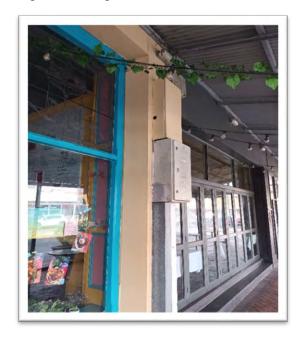
Image 21 - Fuse box cover fixed

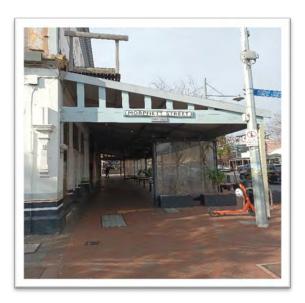
Structural concerns on the attached veranda and a planter box requiring maintenance were identified at 280 Gouger Street

Image 23 - Loose railing fixed.

Requests have been made for the repair, removing the loose rail to make safe, requesting a structural engineering assessment on the rest of the veranda, and requesting the business owner to fix the planter boxes.

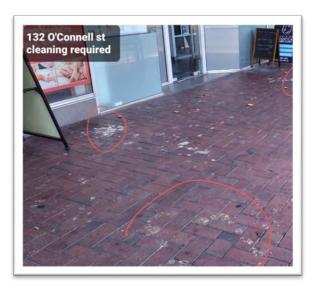
There were isolated areas of concentrated bird droppings requiring cleaning.

As discussed during the audit, the Cleansing Team work hard to provide clean and visually appealing footpaths, with bird faeces an ongoing issue. These instances appear in very short timeframes with birds roosting in groups. Many buildings install bird nesting deterrents as a control mechanism.

Image 33 - Concentrations of bird droppings under roosting areas

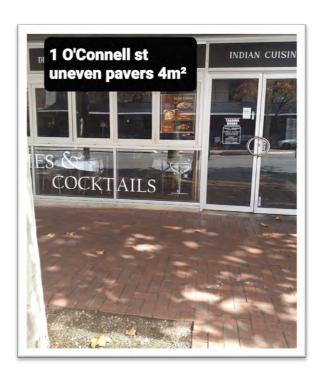
Several areas of raised pavers were observed along O'Connell Street on the western side.

These generally coincided with the interface between the footpath edge and the box around street trees.

Image 35 - Area of paving requiring maintenance

The remaining works total approximately 122m<sup>2</sup> and have been programmed to be completed by the end of the financial year.

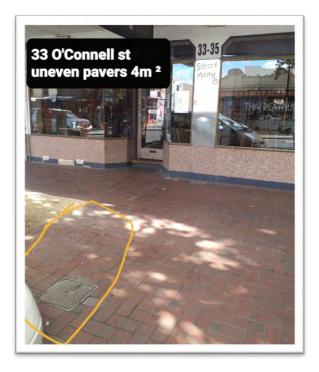
Image 36 - Area of paving requiring maintenance

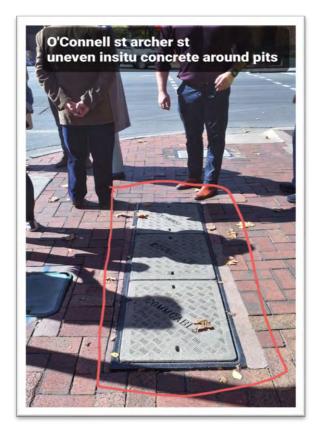
Quality of reinstatements undertaken by Service Authorities were also noted along both sides of O'Connell Street.

Image 37 - Area of paving requiring maintenance

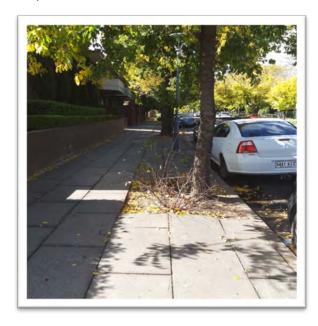
Street trees were generally in good condition, with localised suckering (epicormic growth) at the base of 5 trees and two instances of tree branches requiring removal.

Image 38 - Suckering present in tree at 107 Gover Street

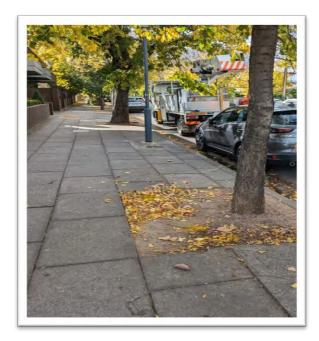
Image 39 - Suckering removed at 107 Gover Street

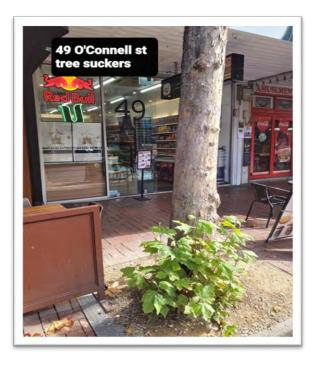
Image 40 - Suckering present in front of 49 O'Connell Street

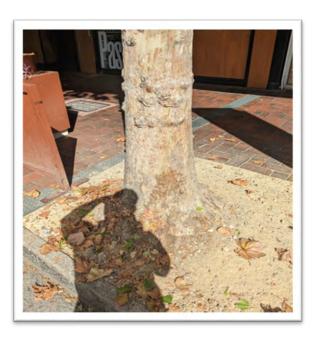
Image 41 - Suckering removed from tree in front of 49 O'Connell Street

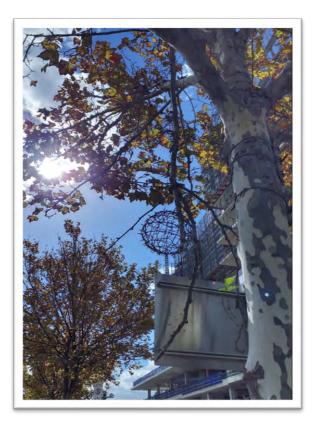
Image 42 - Branch requiring removal 88 O'Connell Street

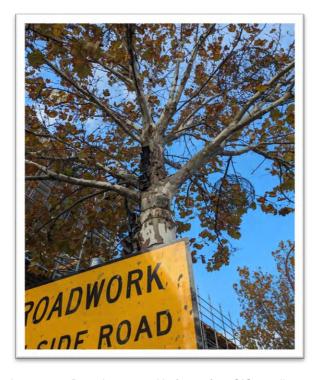
Image 43 - Branch removed in front of 88 O'Connell Street

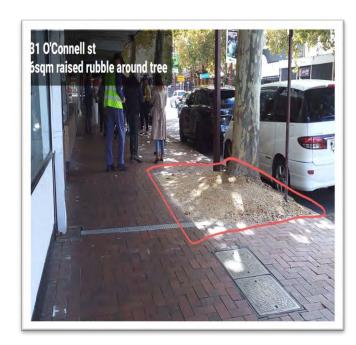
Primarily along the western side of O'Connell Street, the existing mature street trees presented with raised rubble beds because of capping tree roots.

Image 44 - raised rubble.

City Operations staff have capped these to provide a safe footpath network without presenting a risk to the health of the tree. These legacy plantings impact the whole city and solutions to these are limited from a maintenance perspective, where removal of a tree is not warranted.

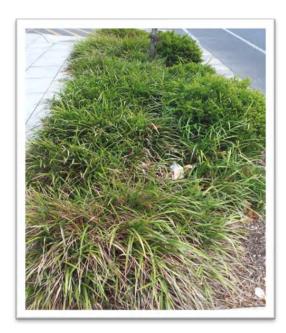
Garden beds presented in good condition. Ten garden beds have been programmed for localised re-planting and general tidy work.

Image 45 - Garden bed at intersection of O'Connell Street and Tynte Street requiring maintenance

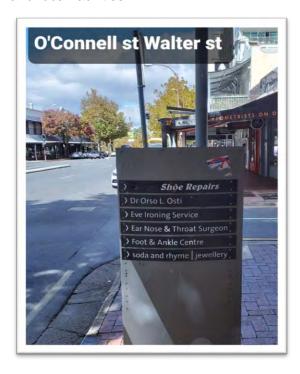
It was noted that directional signage was out of date and had a lacklustre appearance.

Image 47 - Outdated Way Finding Signage

Directional signage is currently being phased out in favour of our new wayfinding strategy across the city, that has a focus on providing pedestrians and cyclists with on-street information, to help connect visitors and locals with public transport, detailed areas, historical walks and local facilities.

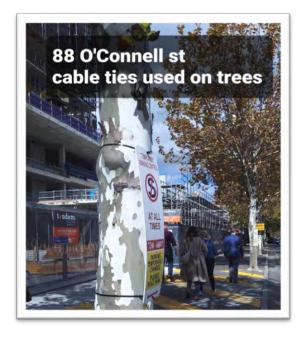
City Operations staff noted that Temporary Parking Control signage was cable tied to trees. These signs have been moved to hard infrastructure to reduce impacts on tree health.

Image 50 - Signage installed on tree.
