DEVELOPMENT NO.:	24020992
APPLICANT:	K Koutsonas 1 Pty Ltd, and John and Evanthia Tsianos C-/ Future Urban Pty Ltd
AGENDA ITEM NO:	3.1
ADDRESS:	187-189 Hutt Street, Adelaide SA 5000
NATURE OF DEVELOPMENT:	Demolition of Local Heritage Place and ancillary building
ZONING INFORMATION:	<p>Zones:</p> <ul style="list-style-type: none"> • City Main Street <p>Subzones:</p> <ul style="list-style-type: none"> • City High Street <p>Overlays:</p> <ul style="list-style-type: none"> • Local Heritage Place <p>Technical Numeric Variations (TNVs):</p> <ul style="list-style-type: none"> • Maximum Building Height (14 Metres) • Maximum Building Height (4 Levels)
LODGEMENT DATE:	18 July 2024
RELEVANT AUTHORITY:	City of Adelaide Council Assessment Panel
PLANNING & DESIGN CODE VERSION:	Planning and Design Code (in effect) Version 2024.12 – 4 July 2024
CATEGORY OF DEVELOPMENT:	Code Assessed - Performance Assessed
NOTIFICATION:	Yes

1. **DETAILED DESCRIPTION OF PROPOSAL**

This application proposes the total demolition of a Local Heritage Place and outbuilding.

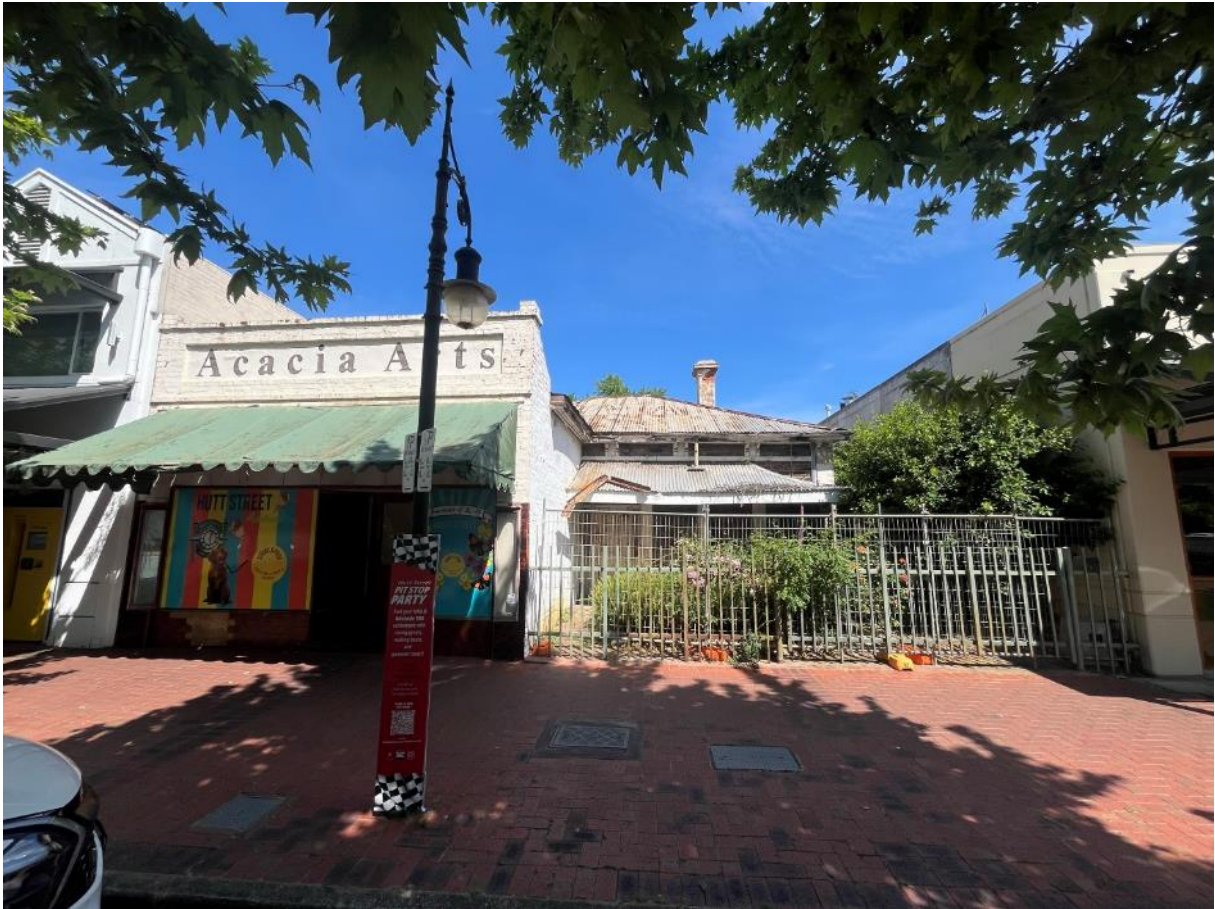
Figure 3.1 – View of subject site from Hutt Street

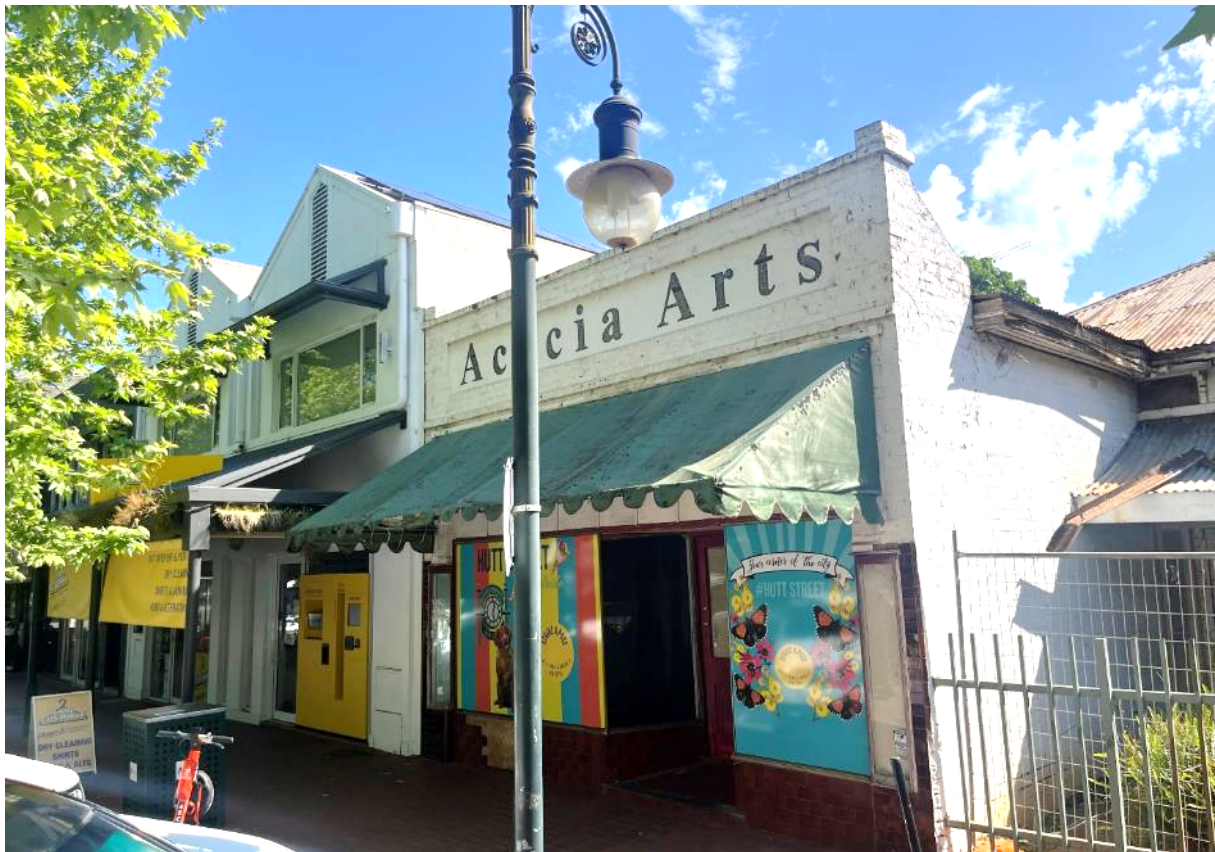
Figure 3.2 – View of subject site from Hutt Street

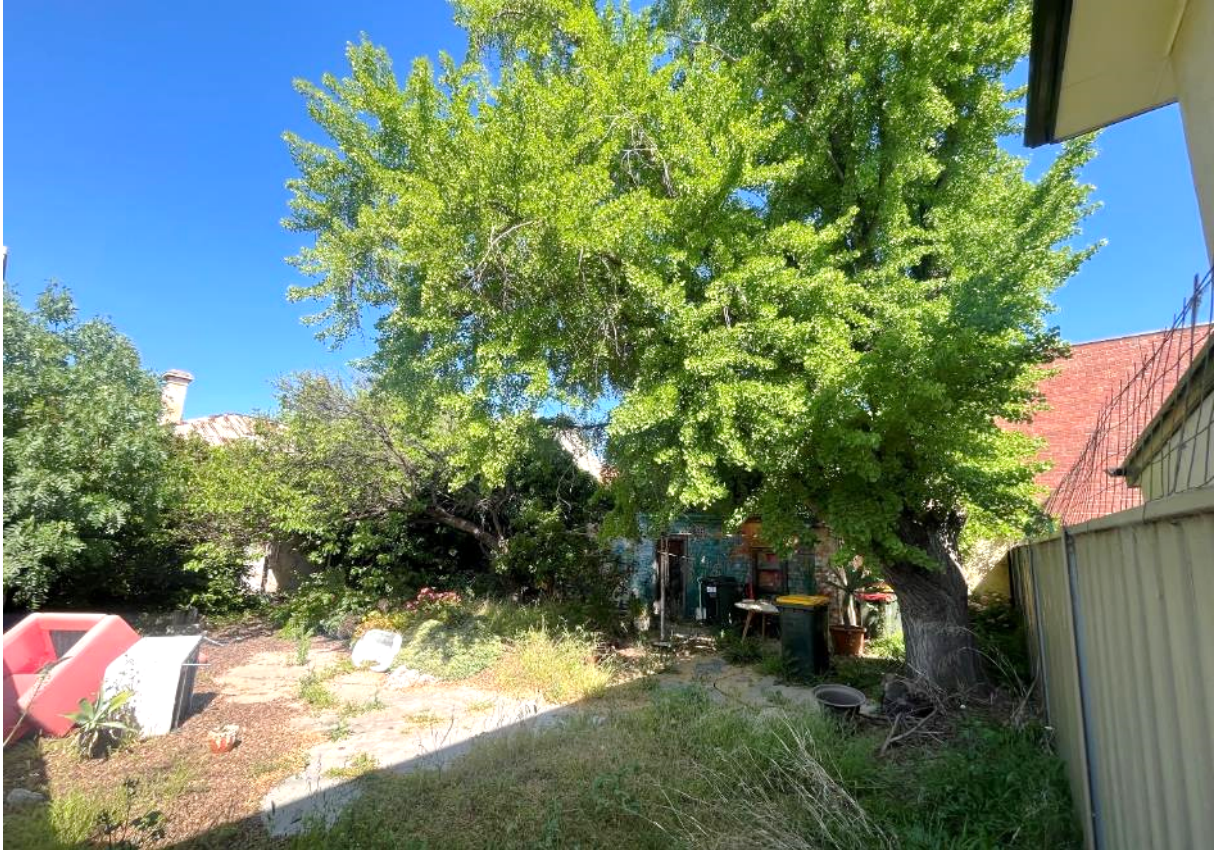
Figure 3.3 – View of rear yard of subject site

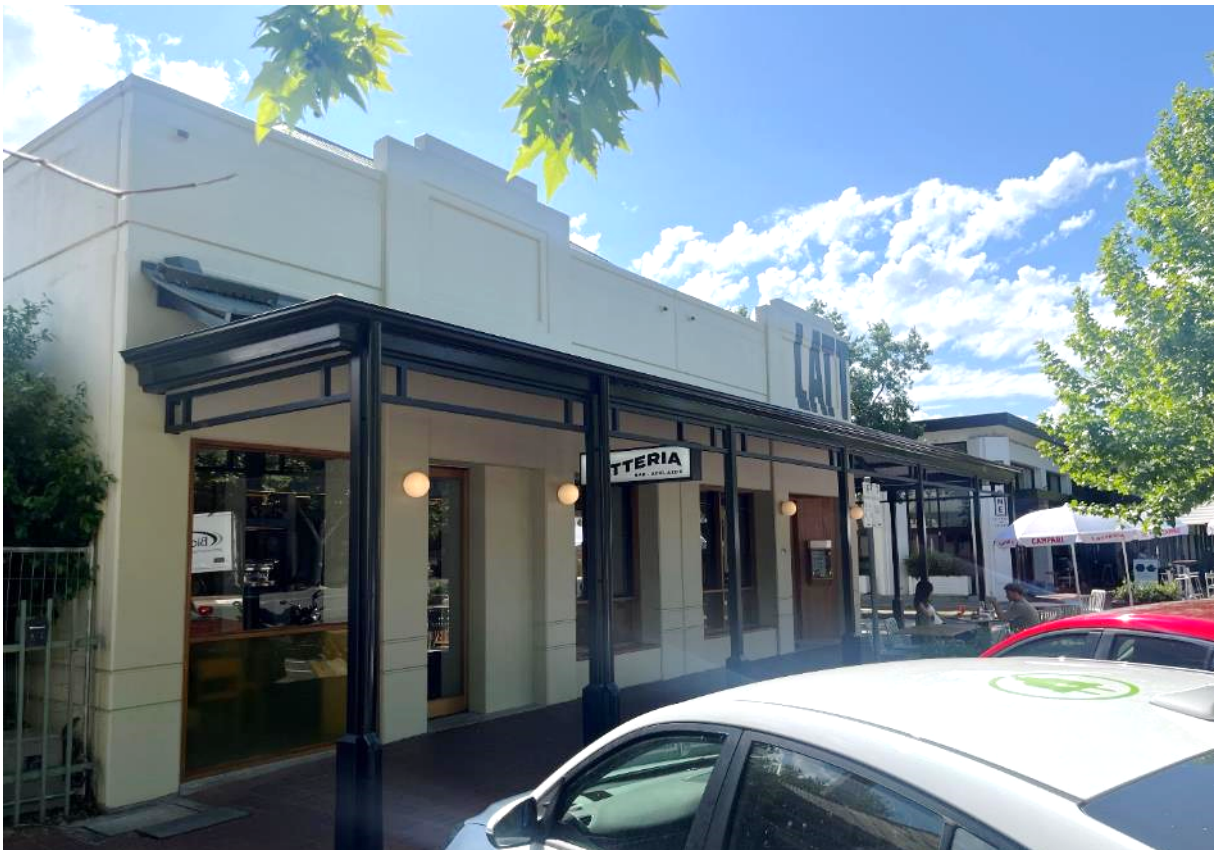
Figure 3.4 – View of neighbouring building to the north fronting Hutt Street

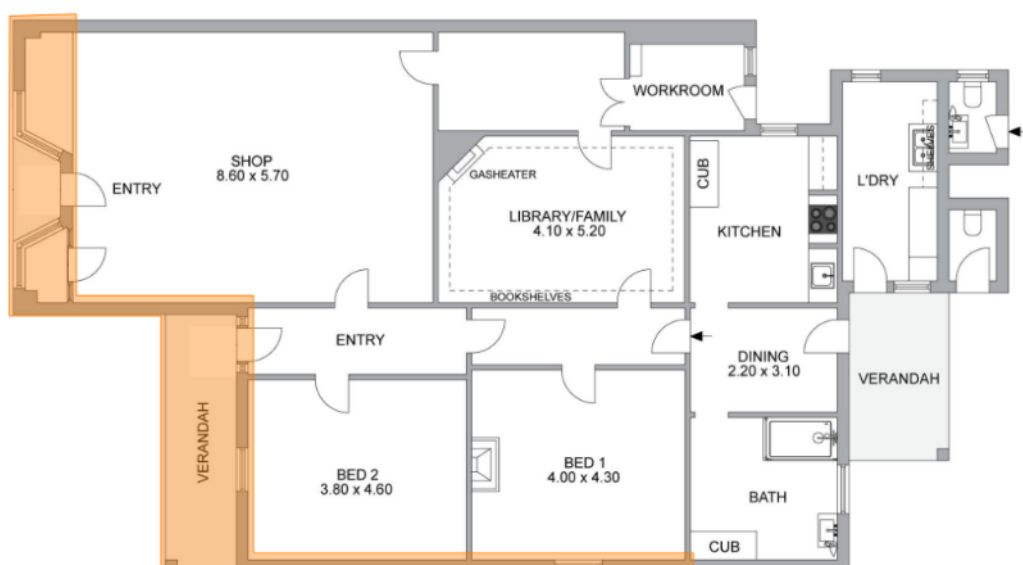
Figure 9.1.1 – Plan view highlighting elements of heritage value (visible roof and chimney not shown)

Council’s heritage advice confirmed the Place is designated as the external form of the shop and dwelling with the street facing original fabric and detailing highlighted as having particular heritage value. Elements included and excluded from the extent of the listing are examined, however discussion focuses primarily on elements of heritage value.
